When swap meeting and looking for door hinges, unless you have your old one or know exactly “what is what”, you are at the mercy of the seller. In this tech article we will show the differences in the door hinges between 1958 to 1968. We will also show how easy it is to rebuild the hinges and make them better than new. Here is a 1958 upper left hand door hinge. The right hand lower door hinge is the same. There are 2 Phillips headed counter sunk screws that hold the outer hinge to the cowl and 2, 1/16" bolts up inside the hinge also (see photo #1). This is a 1958 lower left hand door hinge, it is the same as the right hand upper. You can see the differences between the upper and lower, the holes for the door are the opposite and the inner holes that mount the hinge to the cowl are the opposite (see photo #2).

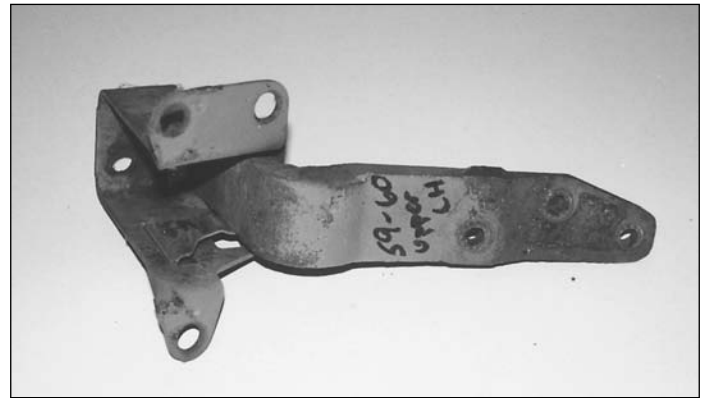
Photo #3

the cowl are the opposite, and the 3 holes in the arm that hold the door to the hinge are the opposite also (see photo #3). The 1959 and 1960 left and right lower door hinges are the same. There are 2 Phillips head screws on the outside of the hinge that hold the hinge to the cowl and (2) 1/16" bolts up inside the hinge that bolt to the cowl also (see photo #4). The hinges for the 1961 through 1964 upper are the same. The upper hinge is held to the cowl with (4) 1/16" bolts. The hinge is just a hinge with no

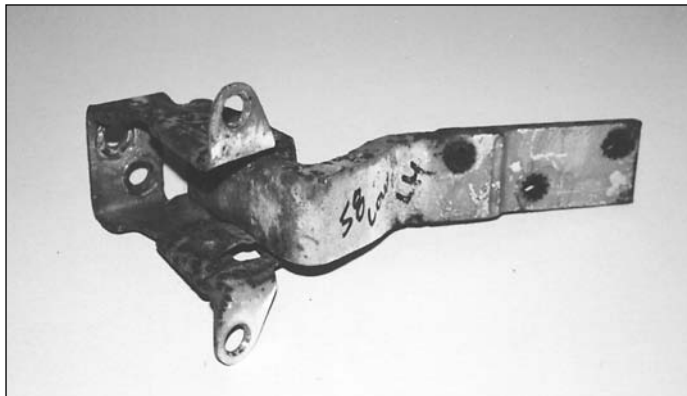
Photo #2

The 1959 and the 1960 door hinges are the same. This is the upper left hand hinge. This hinge is only used in this location. The right hand upper hinge is a mirror image of the left hand side. The inner holes that hold the hinge to

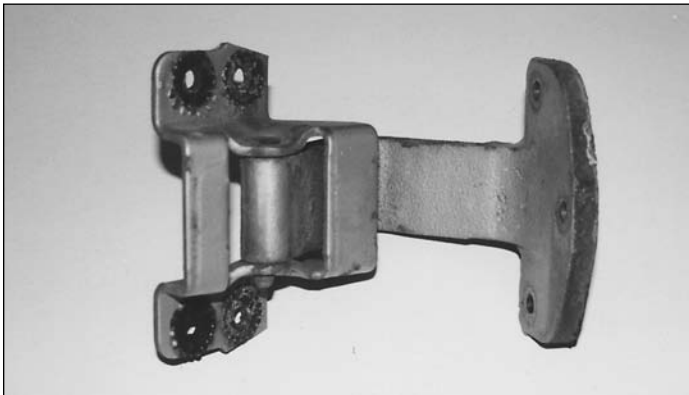
Photo #5

mechanism to hold the door open (see photo #5).

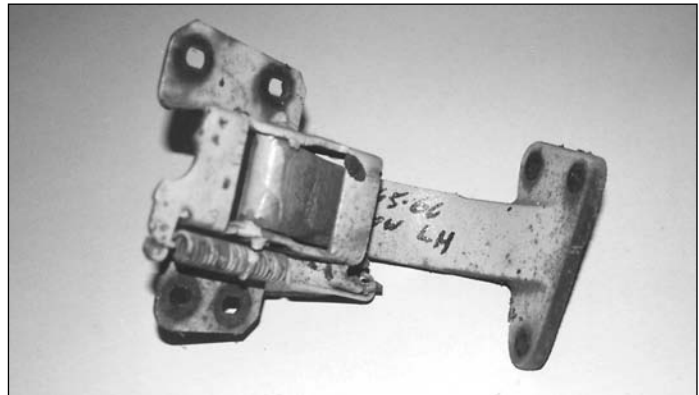
Photo #8

The lower hinge on the 1965-66 is different between the left hand and right right hand. This hinge has (4) $\frac{9}{16}$ " bolts that hold it to the cowl and has a spring, arm and special roller set up like the 61-64 hinges (see photo #8).

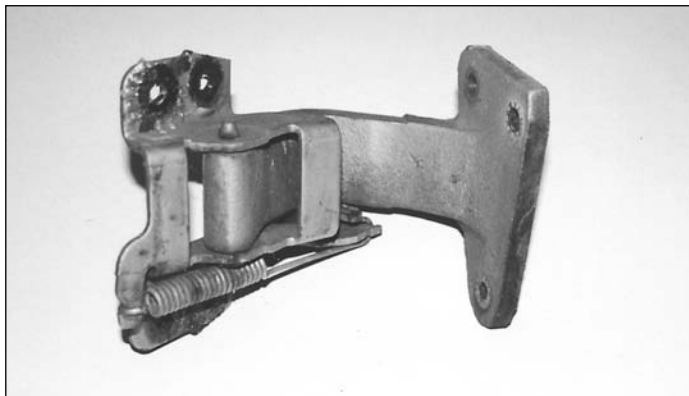
Photo #6

The lower hinge for a 1961-64 is different between the left hand and right hand. This is the left hand. It is held to the cowl with (4) 1/16" bolts and has a spring that pulls on an arm that ride against a special roller to keep the door open. The spring is on the bottom of the hinge (see photo #6). The upper hinges on the 1965-66 are the same. There are (4) 1/16" bolts that hold the hinge to the cowl. This is also just a hinge with no mechanism, to hold the door

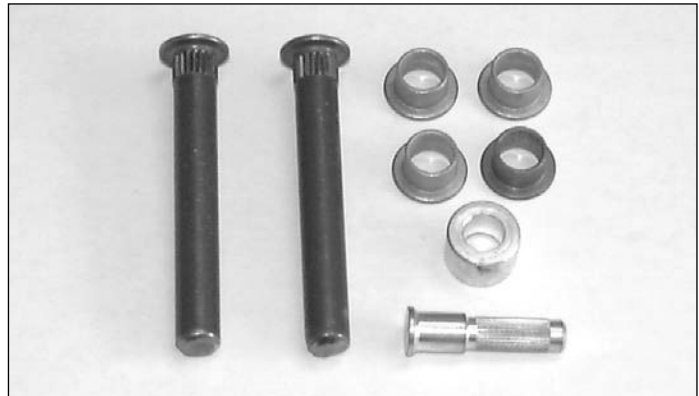
Photo #9

All the door hinges have a hinge pin in them. There are also two bushings in the arm. This is were you get play in the hinge. To replace the pin and bushing is a very simple job, and can be done with basic tools. Our **P/N 535021** is a hinge pin and bushing kit. It comes with (2) new pins, 4 bushings, 1 special roller, and 1 pin for the roller. It will do 2 hinges, 1 upper and 1 lower (see photo #9).

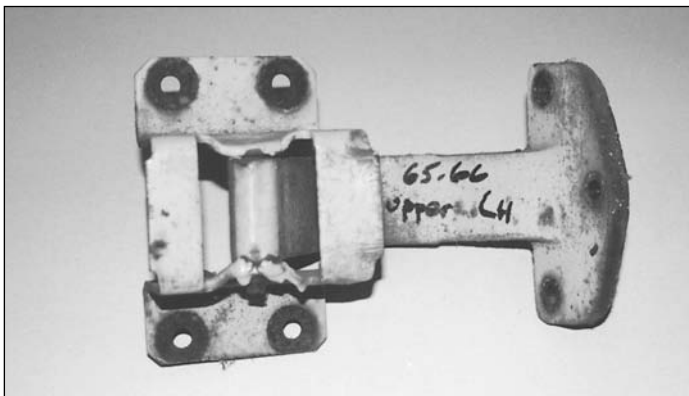
Photo #7

open. It is very close to the 1961-64 door hinge with a little change to the cowl mount (see photo #7).

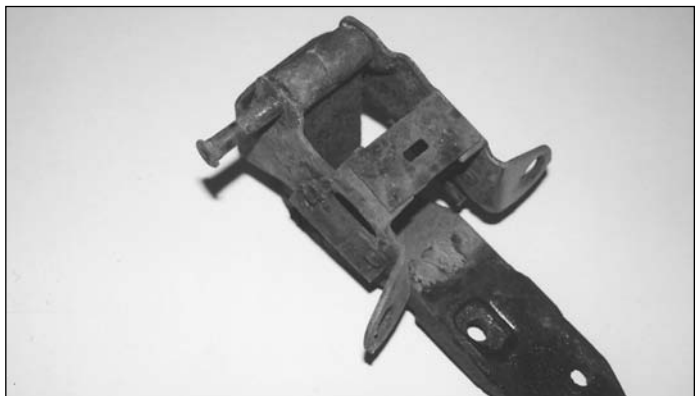
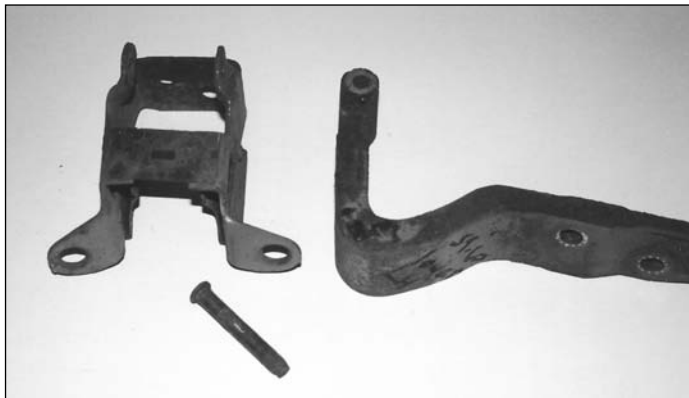
This is a hinge from a 1959-60. The pin has a curled end on it that holds it in place. Using a hammer and punch, the pin can be driven out. (see photos #10 & #11). On these 1959-60 hinges, the bushings are plastic. These can be popped out of the arm with a #2 screw driver (see photo #12). The replacement bushings are made of brass. Once the arm has been cleaned properly using a hammer and a brass punch drive the new bushings in flush with the hinge arm (see photo #13).

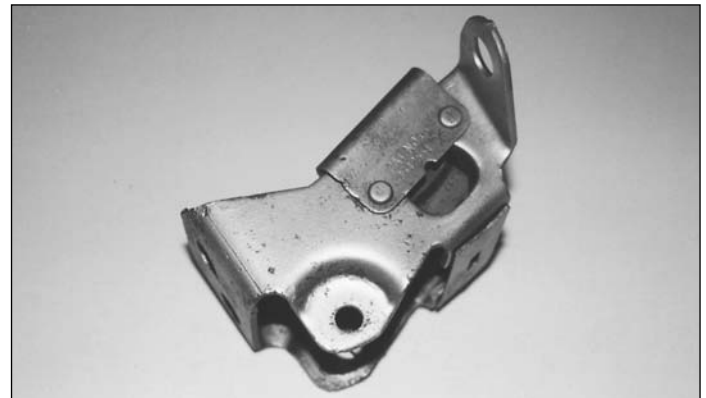
Photo #14

The hinges from 1958 through 1960 have a spring steel flange that hold the door open on the upper and lower hinge (see photo #14). With everything cleaned, you can now drive the new hinge pin in place. Some light grease on the pin will ease installation and operation. The hinge can be in the open or closed position when you do this, it doesn't matter (see photos #15 & #16). The hinge pin

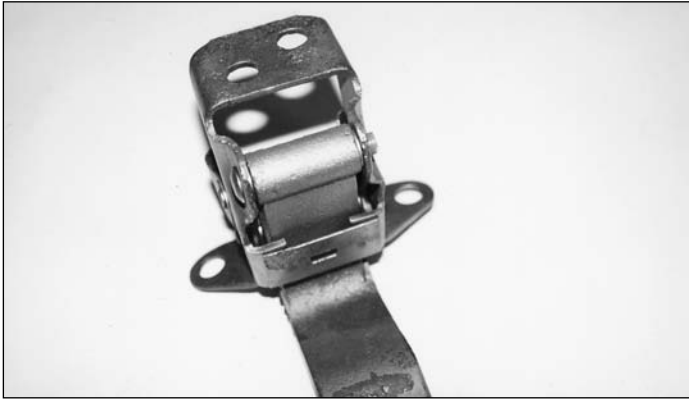
Photo #17

cannot stick out past the edge of the body of the hinge, or it will not fit back in the hinge pocket of the cowl. The pin was about a 1/4" too long on the '59-'60 hinge, so using a hack saw, we cut the pin down, leaving 1/8" sticking through the body of the hinge (see photo #17).

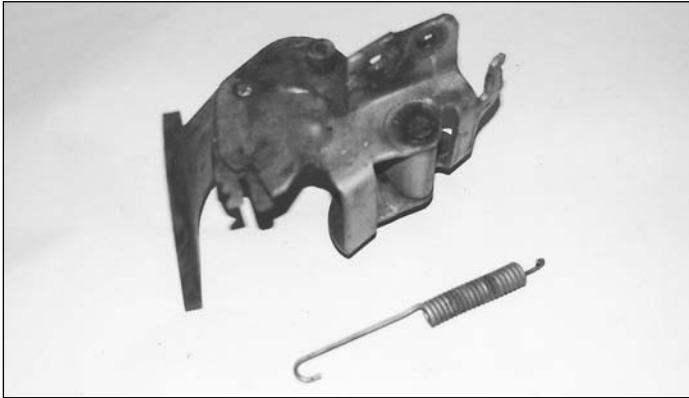
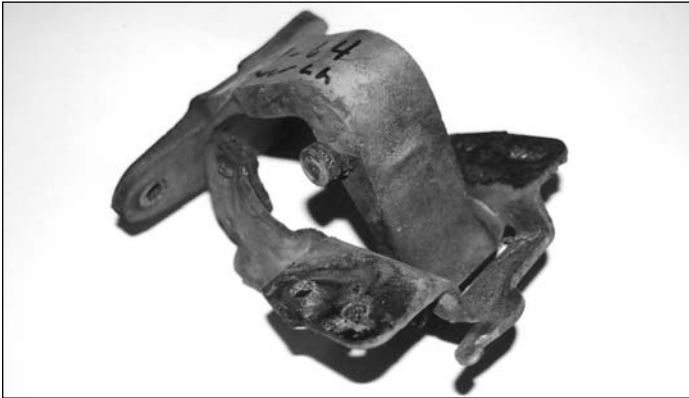
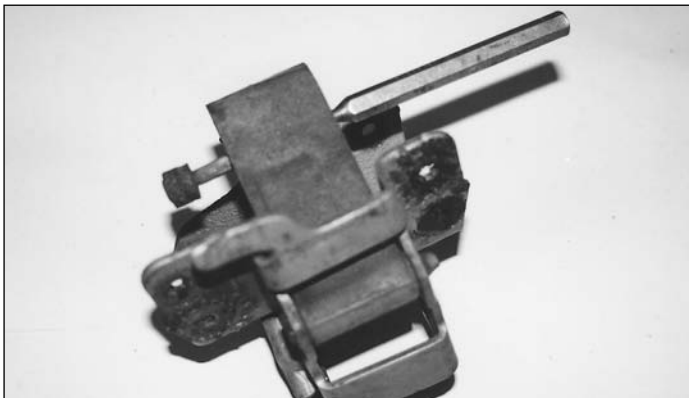
The lower hinges on a 1961-1966 have a spring that hooks to an arm that rolls against a special roller to keep the door open. Kit P/N 535021 includes a new roller and roller pin. To replace the roller and pin, move the hinge to the open position, and remove the spring (see photo #18). This roller is in very bad shape. There is a groove cut in it about half way around, and it is seized up on the pin. This will cause the door to pop while opening it (see photo #19). The pin for the roller is splined and driven into the arm of the hinge. The hole for the pin is drilled all the way through the arm. Using a 1/4" punch, the pin can be driven out (see photo #20).

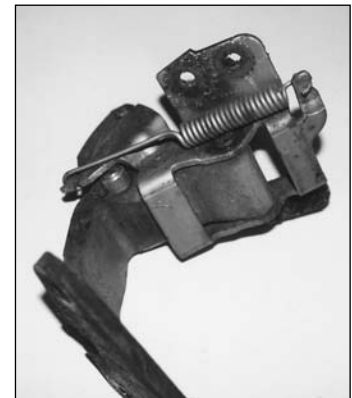
Photo #22

Grease the new pin and roller assembly, and drive the new pin in with the roller on it, until there is just a little play in the roller. DO NOT drive the pin into where the roller won't rotate. Now with the new roller in place, re-install the spring with the hinge in the open position (see photo #22).
